Manhole Inspection Summary

Manhole # S45KK_021MH

Insp Date: **4/15/08 12:05 PM**

Location Address: **Durham**

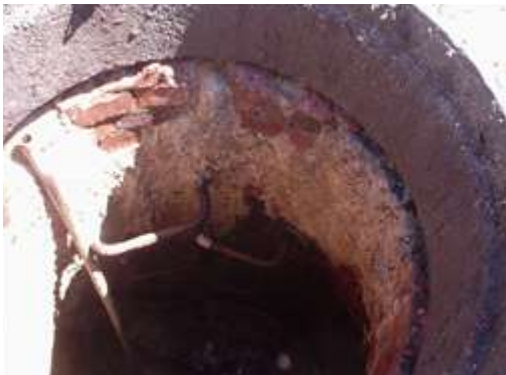
Defect 3

Frame Offset: **1** (in.) Condition: ☐ Sound ☐ Cracked ☒ **Leaks**

Frame Leaks

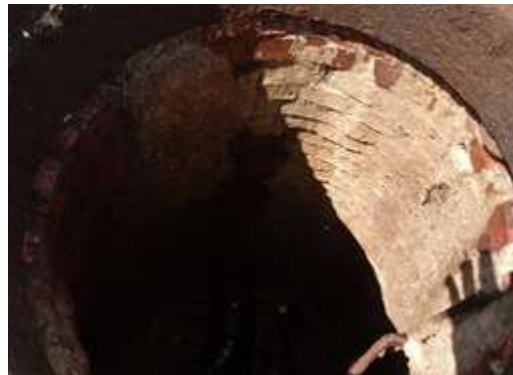
Defect 1

Condition: ☐ Sound ☐ Cracked ☐ Root Intrusion ☒ **Loose Brick** ☐ Deteriorated

Infiltration: ☐ None ☐ Joint ☐ Cracks ☒ **Mortar** ☐ Roots ☒ **Wall**

Adjustment Joint

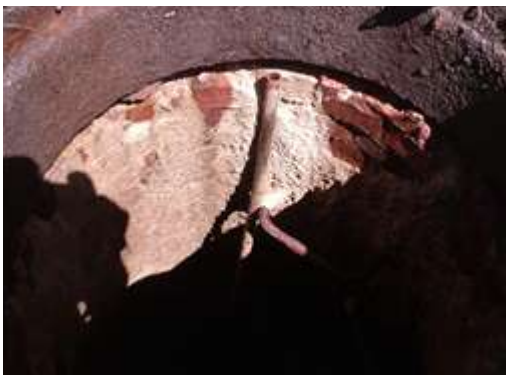
Defect 2

Surcharge ☒ **Evidence Of Surcharge** Depth: **10** (ft.) ☐ Active Surcharge Present

Evidence of Surge

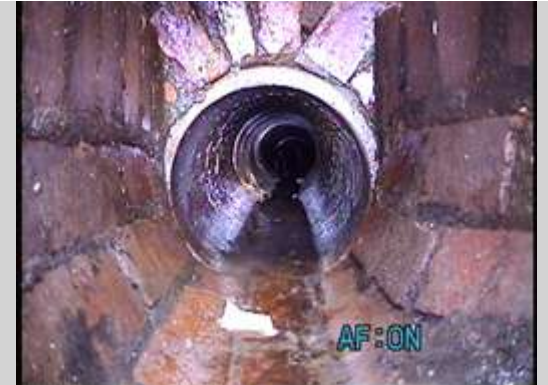
12 O'Clock Outflow

8 in. Circular Gravity Sewer
Pipe Out @ 12 O'Clock

Pipe Height: **8.4** (in.) Rod and Bar (Angled)
Pipe Material: **Clay** ☐ Pipe Lined
Invert Depth: **10.00** (ft.) Flow Characteristics: **Fast**
Deposits: ☒ None ☐ Mud ☐ Sludge ☐ Debris ☐ Grease
Silt Depth: (in.) Deposits Extent:
Infiltration: **None** Pipe Seal Cond: **Sound**

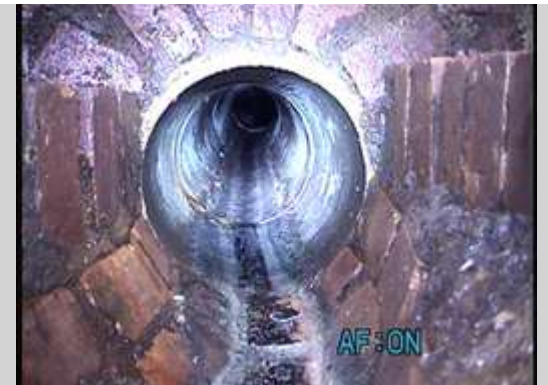
3 O'Clock Inflow

8 in. Circular Gravity Sewer
Pipe In @ 3 O'Clock

Pipe Height: **8.4** (in.) Rod and Bar (Angled)
Pipe Material: **Clay** ☐ Pipe Lined
Invert Depth: **9.50** (ft.) Flow Characteristics: **Slow**
Deposits: ☒ None ☐ Mud ☐ Sludge ☐ Debris ☐ Grease
Silt Depth: (in.) Deposits Extent:
Infiltration: **None** Pipe Seal Cond: **Sound**

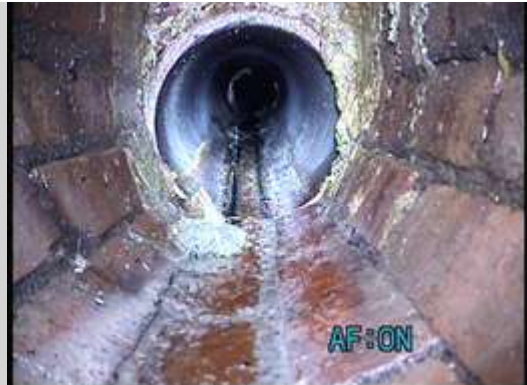
6 O'Clock Inflow

Pipe In @ 6 O'Clock

Infiltration: **None** Pipe Seal Cond: **Sound**

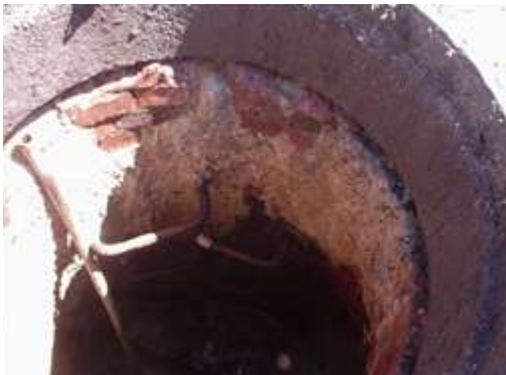
Defect 3

Frame Offset: **1** (in.) Condition: ☐ Sound ☐ Cracked ☒ **Leaks**

Frame Leaks

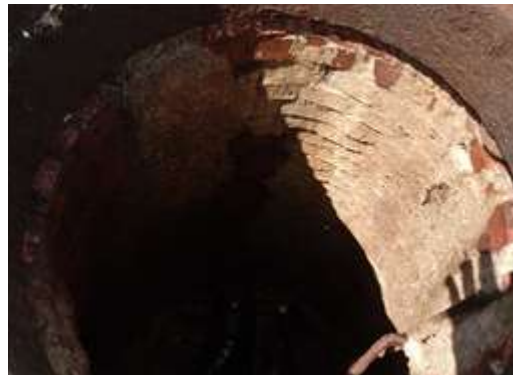
Defect 1

Condition: ☐ Sound ☐ Cracked ☐ Root Intrusion ☒ **Loose Brick** ☐ Deteriorated

Infiltration: ☐ None ☐ Joint ☐ Cracks ☒ **Mortar** ☐ Roots ☒ **Wall**

Adjustment Joint

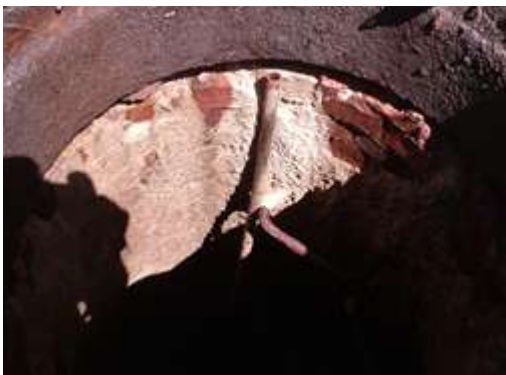
Defect 2

Surcharge ☒ **Evidence Of Surcharge** Depth: **10** (ft.) ☐ Active Surcharge Present

Evidence of Surge

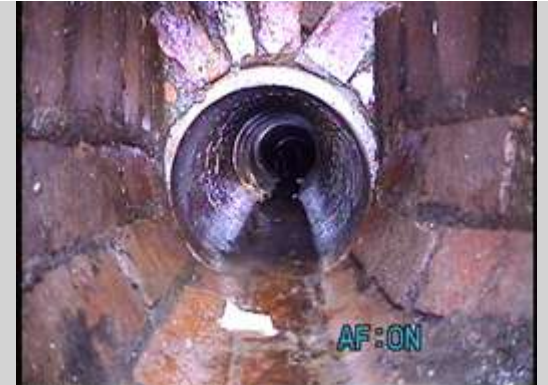
12 O'Clock Outflow

8 in. Circular Gravity Sewer
Pipe Out @ 12 O'Clock

Pipe Height: **8.4** (in.) Rod and Bar (Angled)
Pipe Material: **Clay** ☐ Pipe Lined
Invert Depth: **10.00** (ft.) Flow Characteristics: **Fast**
Deposits: ☒ None ☐ Mud ☐ Sludge ☐ Debris ☐ Grease
Silt Depth: (in.) Deposits Extent:
Infiltration: **None** Pipe Seal Cond: **Sound**

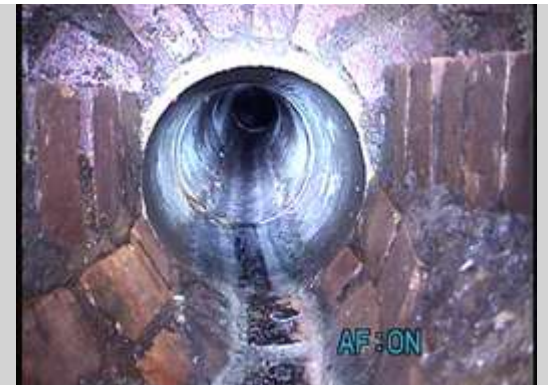
3 O'Clock Inflow

8 in. Circular Gravity Sewer
Pipe In @ 3 O'Clock

Pipe Height: **8.4** (in.) Rod and Bar (Angled)
Pipe Material: **Clay** ☐ Pipe Lined
Invert Depth: **9.50** (ft.) Flow Characteristics: **Slow**
Deposits: ☒ None ☐ Mud ☐ Sludge ☐ Debris ☐ Grease
Silt Depth: (in.) Deposits Extent:
Infiltration: **None** Pipe Seal Cond: **Sound**

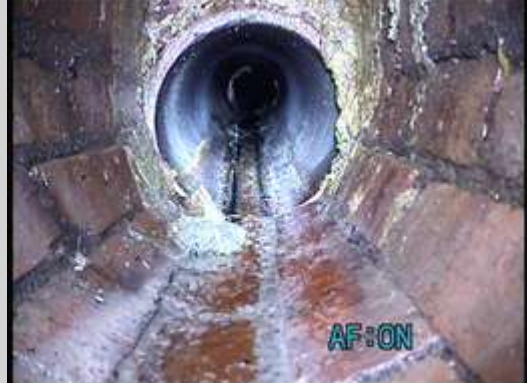
6 O'Clock Inflow

Pipe In @ 6 O'Clock

Infiltration: **None** Pipe Seal Cond: **Sound**
